COMBINED FIRE AND HEALTH & SAFETY RISK ASSESSMENT.

Address of premises:	1-10 Park View Revell Close Swindon SN2 7TW
Responsible Person:	Park View Management Company Swindon Limited
Duty Holder:	Block Management Limited
Person(s) consulted:	No occupier or other relevant person available to consult.
Assessor:	Rob Cockburn
Report validated by:	John Godfrey, GIFireE.
Date of fire risk assessment:	23 rd October 2024/ Reviewed May 2026
Date of previous fire risk assessment:	N/K
Suggested date for review:	October 2026

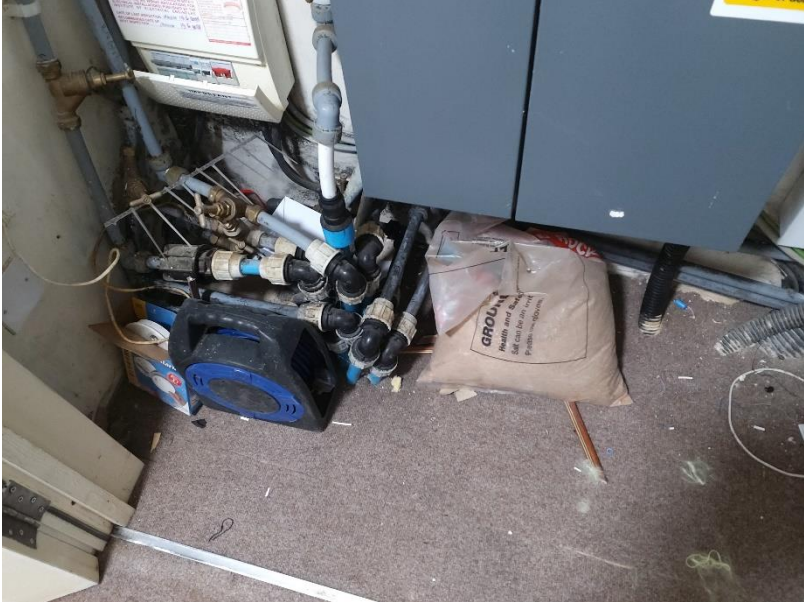
Item	Recommendation	Priority	Timescale	
01	<p>According to the sticker attached to the consumer unit, the fixed electrical installation was last inspected and tested in June 2024. All fixed electrical installations supplying the communal areas of a residential property should be inspected and tested by a competent person every five years in accordance with Electricity at Work Regulations / IEE Wiring Regulations Eighteenth Edition 2019 / British Standard 7671: 2018 and a written Electrical Condition Report (EICR) obtained.</p> <p>It is recommended that the RP create a management action to ensure the electrical installation is retested on a five yearly rolling basis.</p>	3	C	Ongoing action required DH maintain central record of EICR due dates and action as required
02	<p>Housekeeping was found to be of a poor standard at the time of this assessment with the ground floor electrical riser cupboard congested with residents' possessions and storage. It is recommended that the client arrange for the riser cupboard to be cleared as a priority and all residents reminded of the importance of maintaining sterile communal areas, electrical intake cupboards and escape routes.</p>

2	C	Action complete

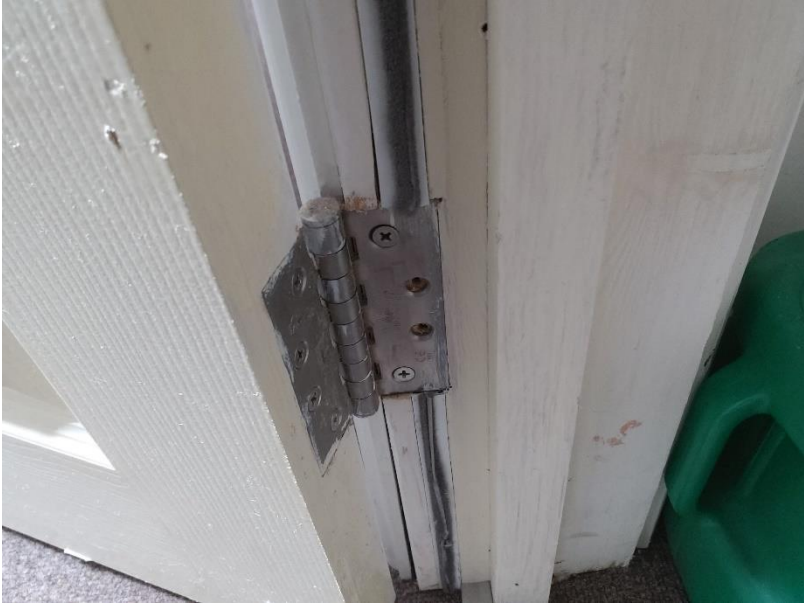
<p>04</p>	<p>It was noted during this fire risk assessment that there were screws missing on the bottom and middle hinge of the left-hand first floor riser door, the middle hinge of the left-hand second floor riser door and bottom hinge of the right-hand second floor riser door which could affect the integrity of the door. It is recommended that the RP installs a new high temperature screw which is in tandem with the fire door set as per Home Office Fire Safety (England) Regulations 2022 – Fire Door Guidance Section 6.7E.</p>

<p>2</p>	<p>C</p>	<p>Action complete</p>
<p>05</p>	<p>As per section 33.2 of Fire Safety in Purpose-Built Block of Flats a type 1 fire risk assessment requires us to conduct a fire door survey on a sample of flat front doors. Door to flat 2 was surveyed during this sample which appeared to be a notional fire door complete with three grade 13 hinges, perkomatic closer and a combined cold smoke and intumescent seal which would be an appropriate fire doorset.</p> <p>It is essential that each flat entrance door is a suitable fire door, providing a minimum of thirty minutes fire resistance, hung on three grade 13 hinges and having a functioning self-closing device fitted that positively closes the door on the latch, together with smoke and intumescent seals. It is recommended therefore that the RP instruct a suitably qualified and competent contractor to conduct a fire door inspection to all flat entrance doors and communal area doors providing advice on suitability. Any shortcomings identified by this inspection should be addressed as a priority by upgrading or replacing the door.</p> <p>Flat entrance doors, communal area doors, the seals and the self-closing devices should then be subjected to an annual inspection and maintenance schedule.</p>	<p>3</p>	<p>C</p>	<p>Ongoing action required Inspection to be scheduled in accordance with current legislation</p>

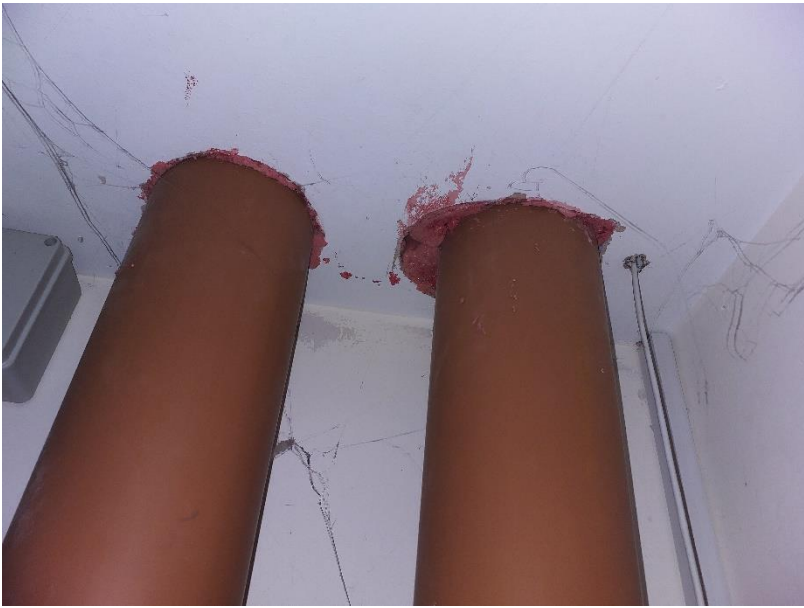
<p>09</p>	<p>It was noted during this fire risk assessment that there was an overuse of pink foam within the second-floor riser. Pink foam is used to seal other fire-resistant materials and should not be used as the main fire resisting compound due to the inconsistent viscosity causing the integrity to fail at different time frames within a fire. It is therefore recommended that the RP instructs a suitably qualified and competent contractor to replace this overuse of pink foam with a compound capable of providing a consistent minimum of 30 minutes fire resistance (like pink plasterboard) in order to protect the means of escape from smoke and fire.</p>

<p>2</p>	<p>B</p>	<p>Action complete contractor reviewed</p>
-----------	---	----------	----------	--

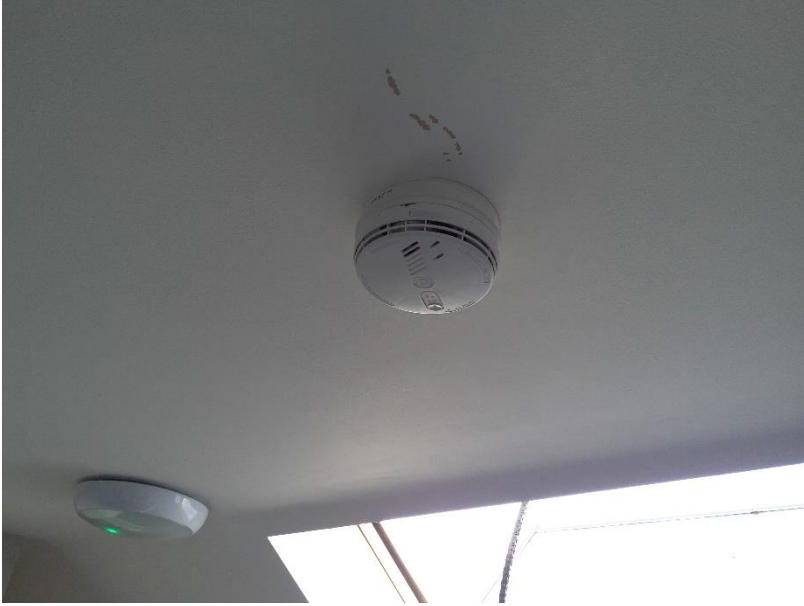
<p>10</p>	<p>It was noted during this fire risk assessment that there were detectors installed for the AOV however upon activation they would sounds an alarm. Having the detectors sound an alarm could be considered as an overprovision for this purpose-built block of flats implementing a stay put evacuation policy. Consideration therefore could be given by the RP as to the silencing of the detectors, so their only purpose is to open the AOV in the event of a fire. This is in line with current fire safety guidance for purpose-built flats.</p>

<p>3</p>	<p>B</p>	<p>Action complete replaced with silent detectors to open AOV</p>
<p>11</p>	<p>Each flat is responsible for their own fire precautions and it is recommended that the RP advise each resident of the importance of installing smoke detectors within their flat. One battery operated smoke detector in the lobby of each flat would be the minimum provision, however mains powered smoke detectors, each with a battery backup, installed within the escape route of each flat, in all rooms that communicate with the escape route and a heat detector within the kitchen, interlinked to form a BS5839-6: 2019 Grade D detection system with LD2 coverage would be the preferred and safest option for each occupant.</p>	<p>3</p>	<p>C</p>	<p>Ongoing action required DH provide annual safety notice and via website</p>

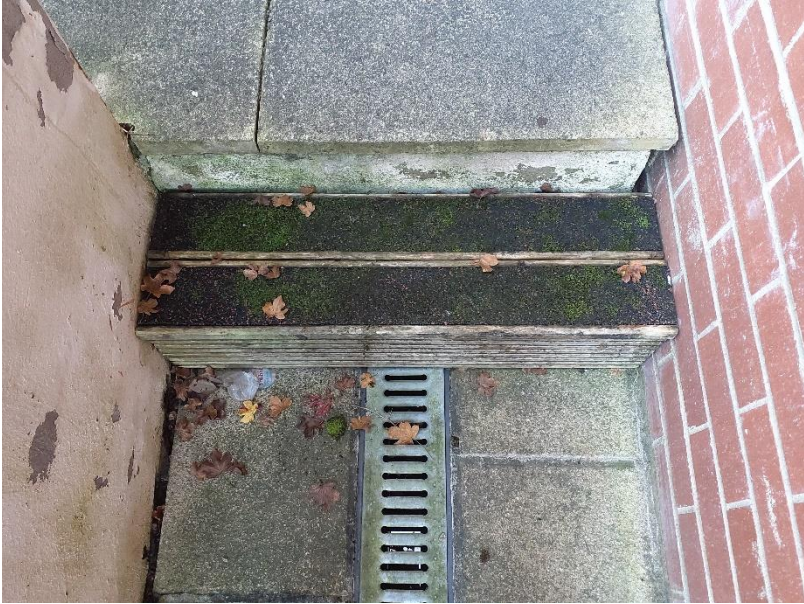
16	<p>The surrounding areas of the premises including hard and soft landscaping and car parking areas were found to be in good visual condition with paved and Tarmacked surfaces reasonably level and free from major indentations or potholes.</p> <p>Landscaping & external grounds maintenance is of an acceptable standard.</p> <p>These areas should be periodically inspected by the RP and the results of each inspection recorded.</p>	3	C	<p>Ongoing action required DH inspect communal areas</p>
17	<p>It was noted during this risk assessment that there was a build up of moss on the step adjacent to the front door. This could cause a slipping hazard in wet conditions. It is therefore recommended that the RP has this moss removed and this be implemented with part of the periodical inspection by the RP.</p>

2	B	<p>Ongoing Action required</p> <p>To be reviewed on routine inspection</p>
