# COMBINED FIRE AND HEALTH & SAFETY RISK ASSESSMENT.

| Address of premises: | 1-10 Park View<br>Revell Close<br>Swindon<br>SN2 7TW |
| Date of fire risk assessment: | 23 <sup>rd</sup> October 2024 |

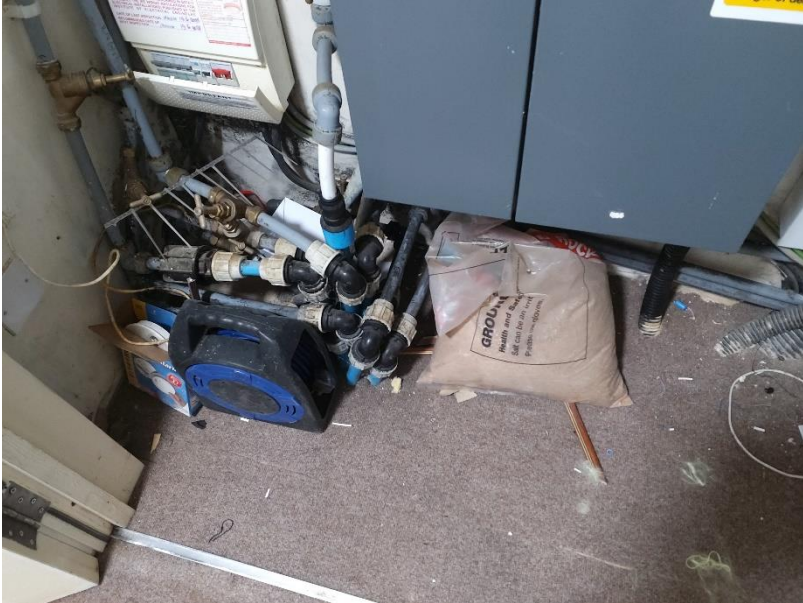
| Item | Recommendation | Priority | Timescale | |
|---|---|---|---|---|
| 02 | <p>Housekeeping was found to be of a poor standard at the time of this assessment with the ground floor electrical riser cupboard congested with residents' possessions and storage. It is recommended that the client arrange for the riser cupboard to be cleared as a priority and all residents reminded of the importance of maintaining sterile communal areas, electrical intake cupboards and escape routes.</p> | 2 | C | Action required<br><br>Items to be removed by residents or removal arranged by RP/DH |

| <p>Housekeeping was found to be of a poor standard at the time of this assessment with the ground floor electrical riser cupboard congested with residents' possessions and storage. It is recommended that the client arrange for the riser cupboard to be cleared as a priority and all residents reminded of the importance of maintaining sterile communal areas, electrical intake cupboards and escape routes.</p> <p>Waste is well managed with the bin store located away from the building adjacent to the carpark.</p> | | |

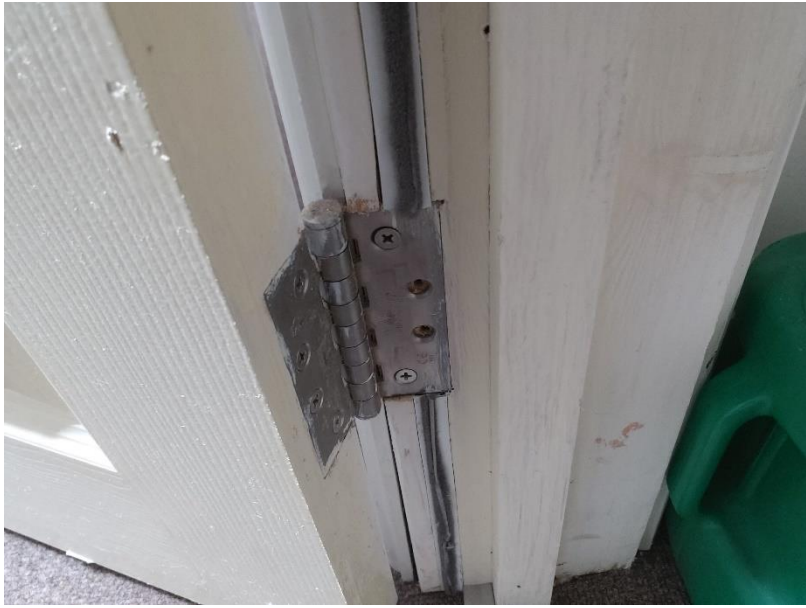
| 04 | <p>It was noted during this fire risk assessment that there were screws missing on the bottom and middle hinge of the left-hand first floor riser door, the middle hinge of the left-hand second floor riser door and bottom hinge of the right-hand second floor riser door which could affect the integrity of the door. It is recommended that the RP installs a new high temperature screw which is in tandem with the fire door set as per Home Office Fire Safety (England) Regulations 2022 – Fire Door Guidance Section 6.7E.</p> | 2 | C | Action required Contract or to make repairs |

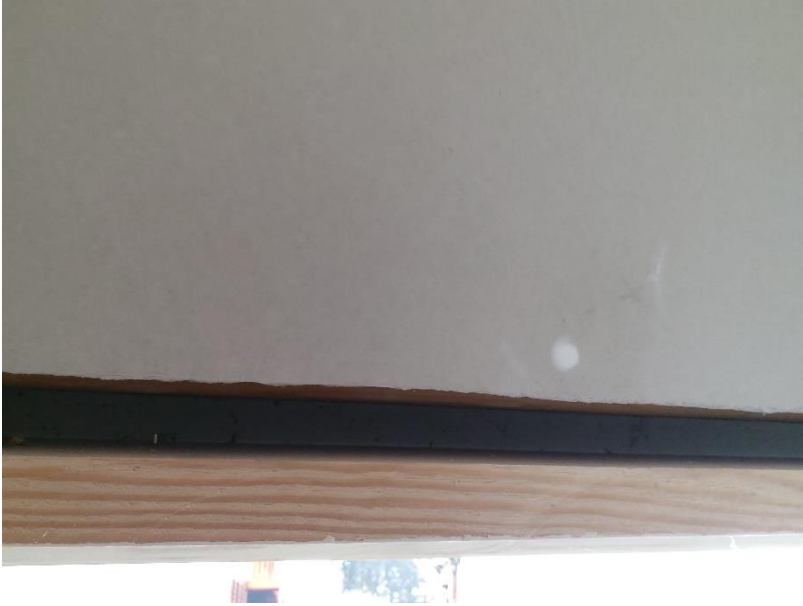
| 07 | <p>It was noted during this fire risk assessment that there were large gaps around the frame within the ground floor riser cupboard. This could allow smoke and fire to spread into the means of escape as the integrity of the fire resistance cannot be verified. It is therefore recommended that the RP instructs a suitably qualified and competent contractor to fully compartment the riser cupboard to the means of escape with a suitable compound capable of providing a minimum of 30 minutes fire resistance.</p> | 1 | B | Action required Contractor to undertake repairs |

| <p>It was noted during this fire risk assessment that there were large gaps around the frame within the ground floor riser cupboard. This could allow smoke and fire to spread into the means of escape as the integrity of the fire resistance cannot be verified. It is therefore recommended that the RP instructs a suitably qualified and competent contractor to fully compartment the riser cupboard to the means of escape with a suitable compound capable of providing a minimum of 30 minutes fire resistance.</p> <p>It was noted during this fire risk assessment that the second-floor riser had a small breach within it which could allow smoke and fire to spread into the means of escape. It is therefore recommended that the RP instructs a suitably qualified and competent contractor to repair the breach with a suitable compound capable of providing a minimum of 30 minutes fire resistance.</p> <p>It was noted during this fire risk assessment that there was an overuse of pink foam within the second-floor riser. Pink foam is used to seal other fire-resistant materials and should not be used as the main fire resisting compound due to the inconsistent viscosity causing the integrity to fail at different time frames within a fire. It is therefore recommended that the RP instructs a suitably qualified and competent contractor to replace this overuse of pink foam with a compound capable of providing a consistent minimum of 30 minutes fire resistance (like pink plasterboard) in order to protect the means of escape from smoke and fire.</p> | | |

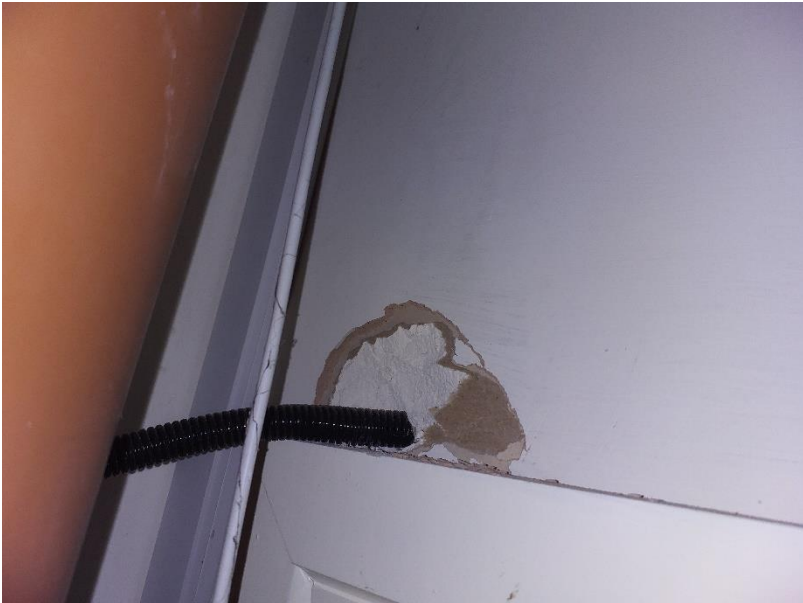
| 08 | <p>It was noted during this fire risk assessment that the second-floor riser had a small breach within it which could allow smoke and fire to spread into the means of escape. It is therefore recommended that the RP instructs a suitably qualified and competent contractor to repair the breach with a suitable compound capable of providing a minimum of 30 minutes fire resistance.</p> | 2 | B | Action required Contractor to undertake repairs |

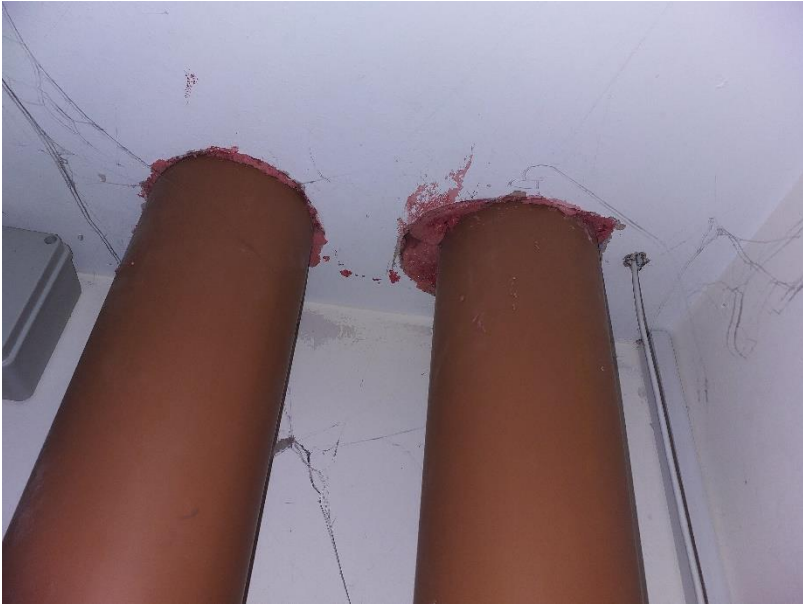
| <p>09</p> | <p>It was noted during this fire risk assessment that there was an overuse of pink foam within the second-floor riser. Pink foam is used to seal other fire-resistant materials and should not be used as the main fire resisting compound due to the inconsistent viscosity causing the integrity to fail at different time frames within a fire. It is therefore recommended that the RP instructs a suitably qualified and competent contractor to replace this overuse of pink foam with a compound capable of providing a consistent minimum of 30 minutes fire resistance (like pink plasterboard) in order to protect the means of escape from smoke and fire.</p> | <p>2</p> | <p>B</p> | <p>Action required Contractor to make repairs</p> |

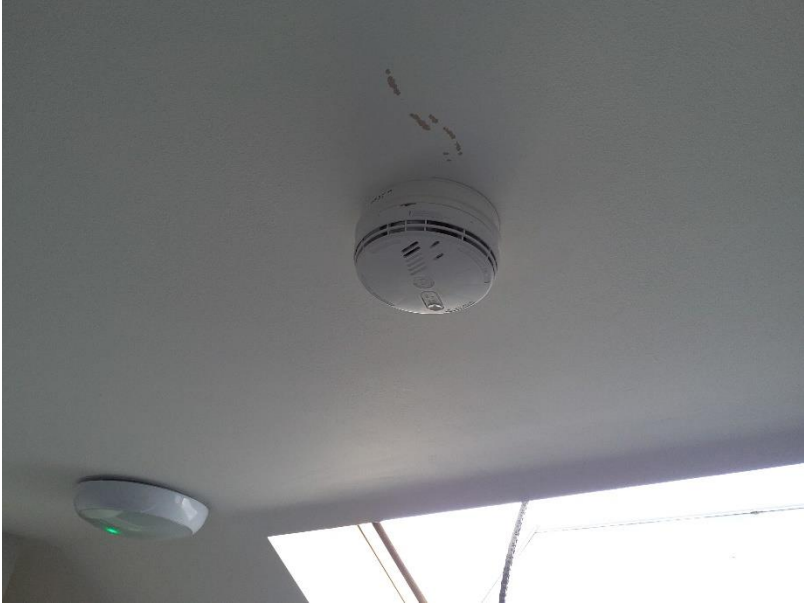
| 10 | <p>It was noted during this fire risk assessment that there were detectors installed for the AOV however upon activation they would sounds an alarm. Having the detectors sound an alarm could be considered as an overprovision for this purpose-built block of flats implementing a stay put evacuation policy. Consideration therefore could be given by the RP as to the silencing of the detectors, so their only purpose is to open the AOV in the event of a fire. This is in line with current fire safety guidance for purpose-built flats.</p> | 3 | B | Action required<br>RP to consider removal |

| <p>It was noted during this fire risk assessment that there were detectors installed for the AOV however upon activation they would sounds an alarm. Having the detectors sound an alarm could be considered as an overprovision for this purpose-built block of flats implementing a stay put evacuation policy. Consideration therefore could be given by the RP as to the silencing of the detectors, so their only purpose is to open the AOV in the event of a fire. This is in line with current fire safety guidance for purpose-built flats.</p> <p>Each flat is responsible for their own fire precautions and it is recommended that the RP advise each resident of the importance of installing smoke detectors within their flat. One battery operated smoke detector in the lobby of each flat would be the minimum provision, however mains powered smoke detectors, each with a battery backup, installed within the escape route of each flat, in all rooms that communicate with the escape route and a heat detector within the kitchen, interlinked to form a BS5839-6: 2019 Grade D detection system with LD2 coverage would be the preferred and safest option for each occupant.</p> | | |

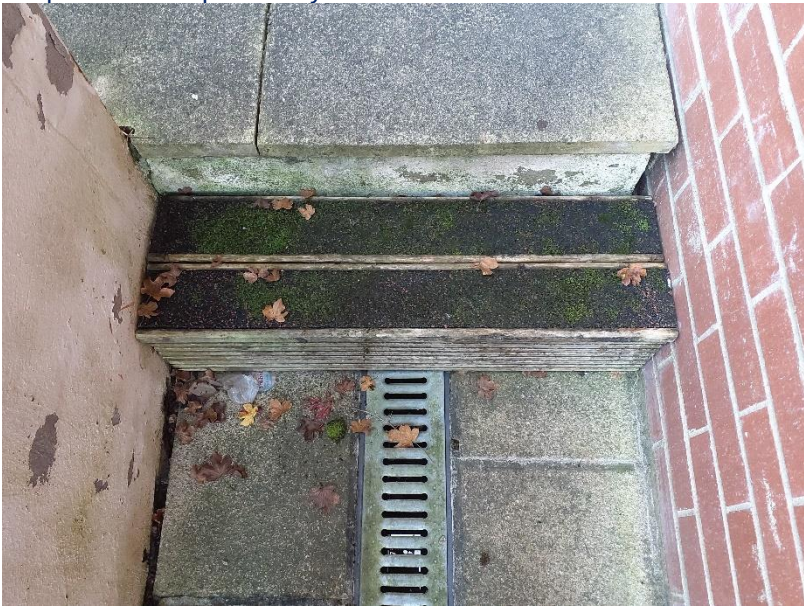
| 17 | <p>It was noted during this risk assessment that there was a build up of moss on the step adjacent to the front door. This could cause a slipping hazard in wet conditions. It is therefore recommended that the RP has this moss removed and this be implemented with part of the periodical inspection by the RP.</p> | 2 | B | Action required<br>Contractor to action |
